Patea Hydro Electric Power Scheme

Lake Rotorangi Hazard Survey

Lake Rotorangi Hazard Identification Survey

Report Date: 26 August 2011
Surveyed Between: 25 – 27 July 2011

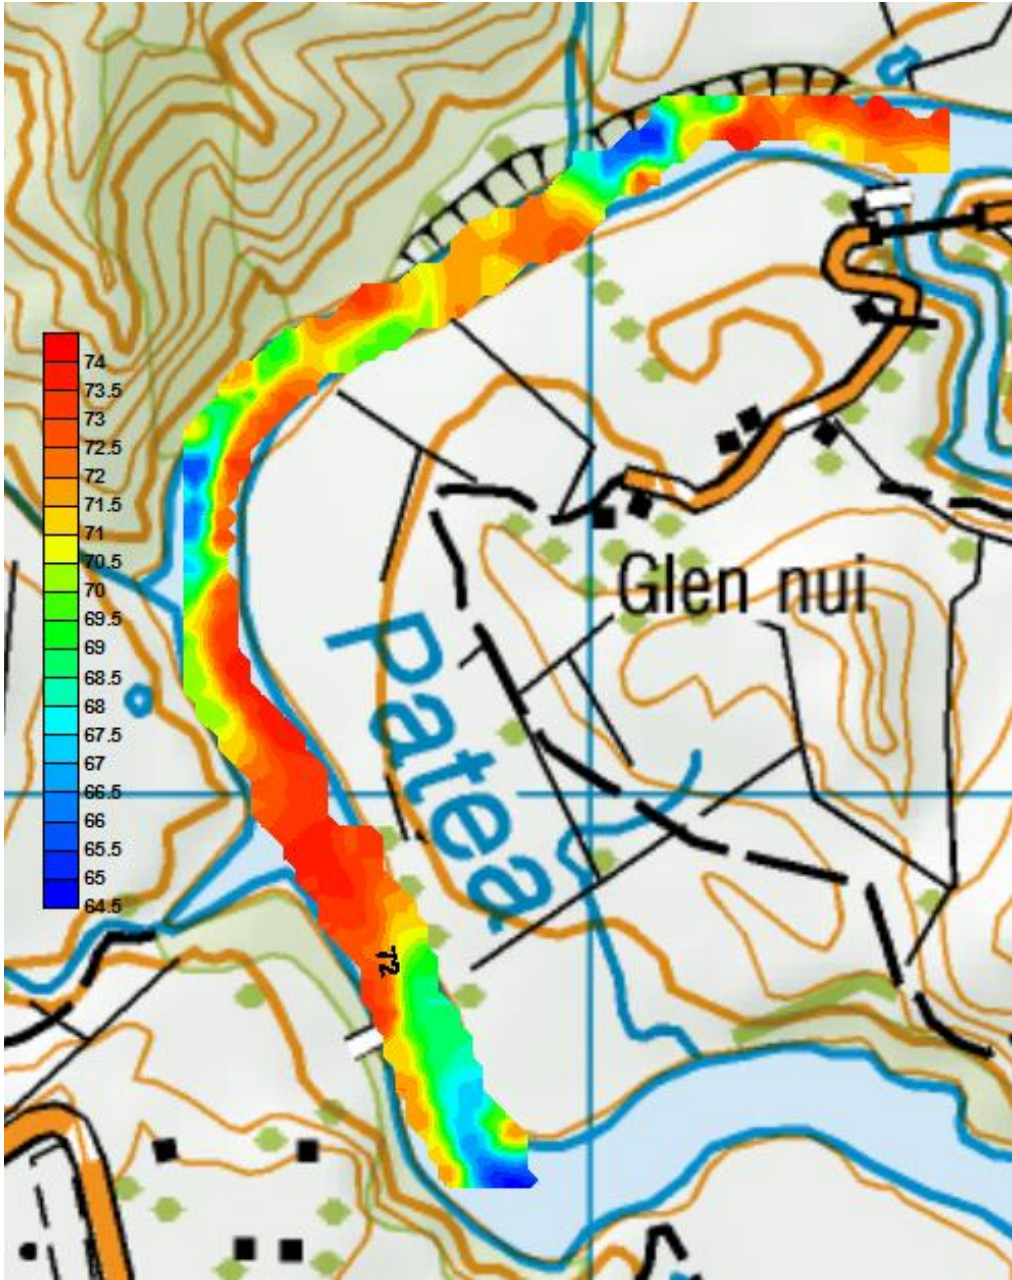
Figure 2: Colour banded bathymetry in the Glen Nui Reach

Areas of the Glen Nui reach were very shallow with the low lake level. Large sand banks are evident where the lake bends, and at the tributary confluence north of the Caniwi lodge landing. It is recommended that during times of low lake levels this area is navigated slowly or avoided if possible.

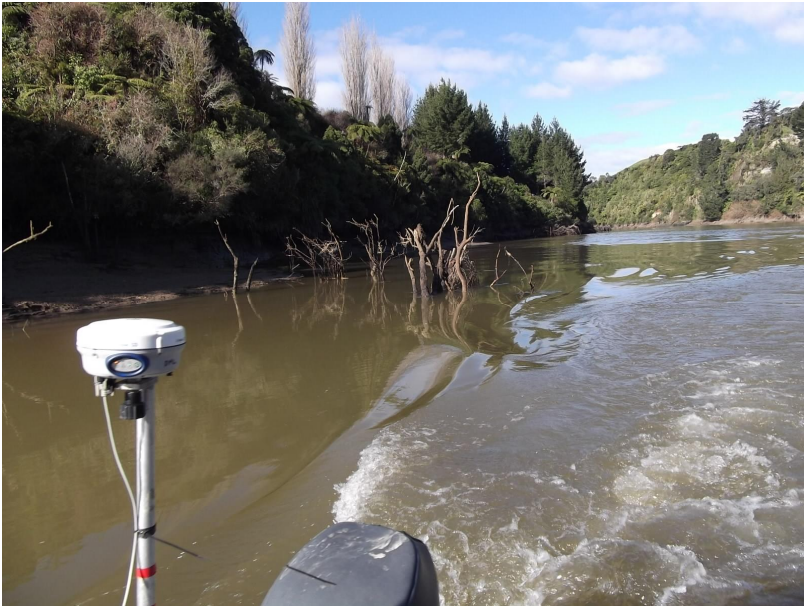
A1a – Submerged Branches on left bank, downstream of Glen Nui

A line of partially submerged branches extending approximately 10m perpendicular to the lake edge.

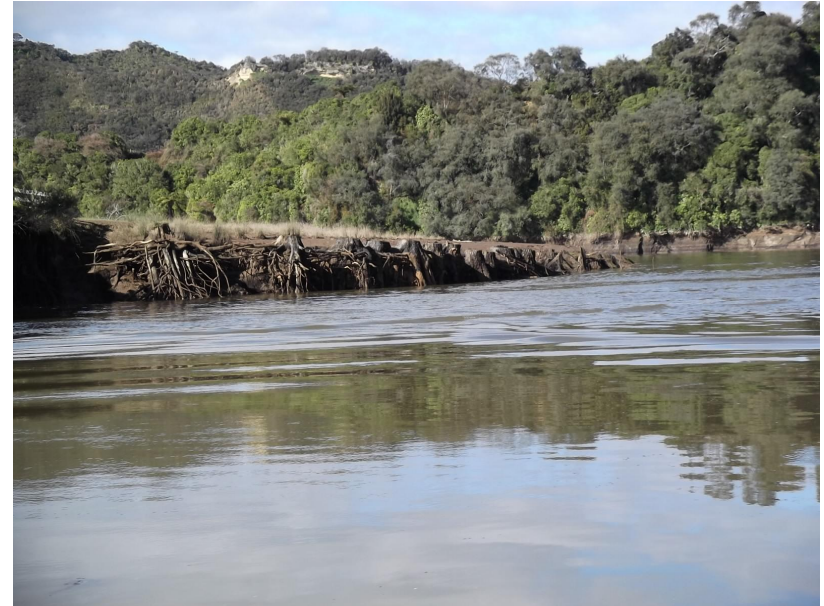
A1b – Tree Stumps/Roots on left bank, downstream of Glen Nui

A line of tree stumps that would be submerged with regular lake levels. This is near a lake corner where recreational boat users apparently come close to the lake edge.

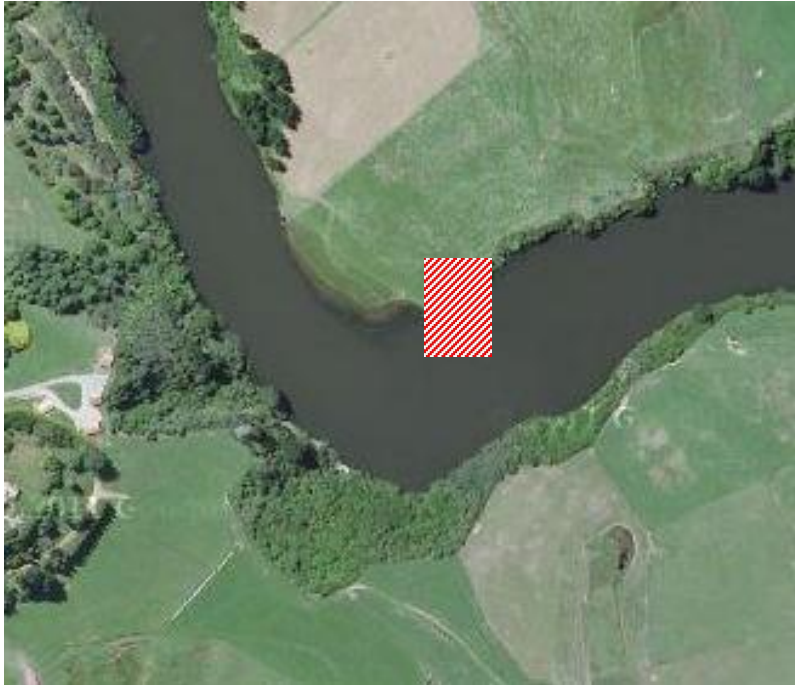
A2 – Fallen Pine Tree on left bank.

A large dead pine tree has collapsed into the lake. There are several partially submerged branches and hazards in the immediate area surrounding the tree..

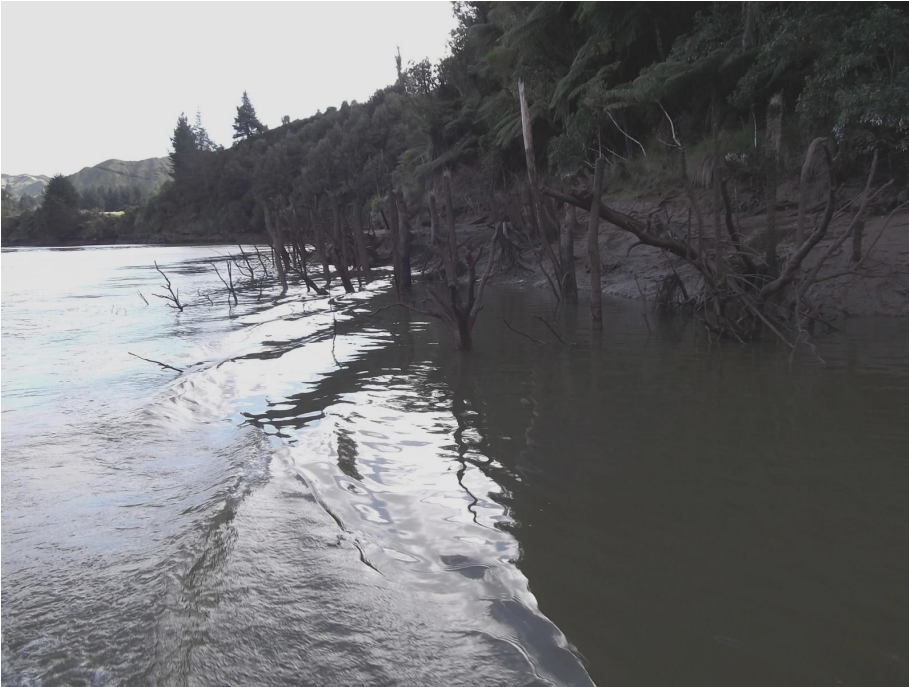
A3 – Semi Submerged Braches on left bank

A large area of lake bank with several bare tree trunks extending into the lake.

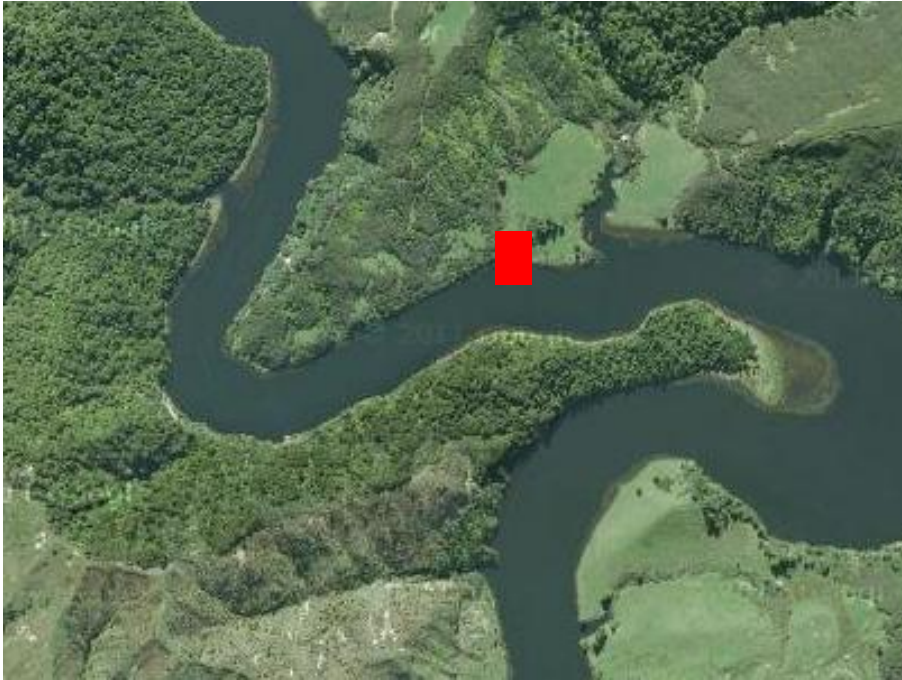
A4 – Exposed Tree Branch on left bank downstream of Otairira Stream

An exposed tree branch extends 10m out from the lake bank, 1m above the lake level. Will cover with normal lake levels

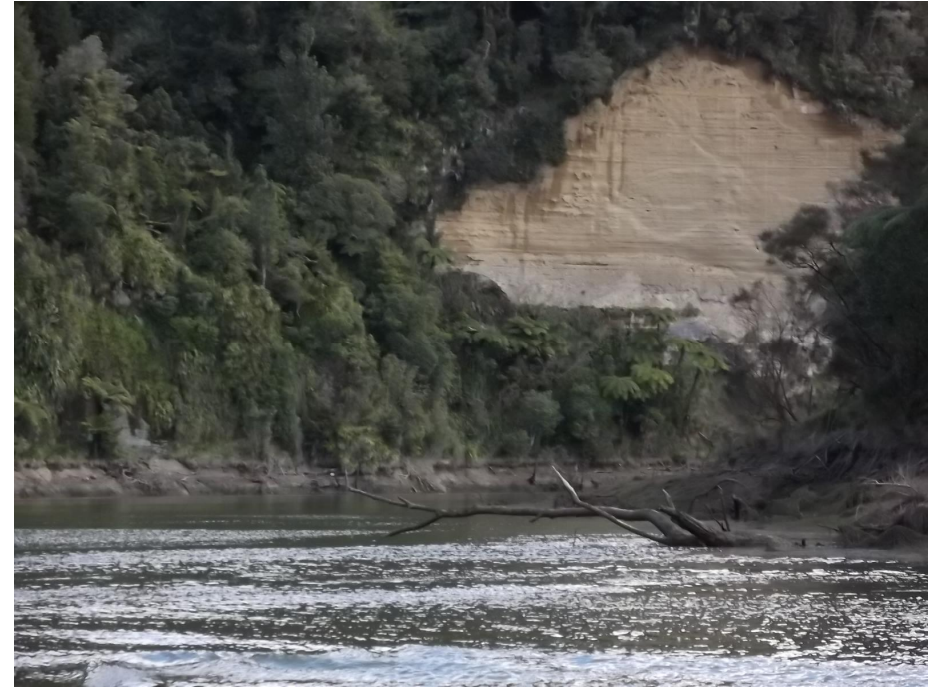
A4 – Exposed Tree Branch on left bank

Photo of tree hazard extending into lake.

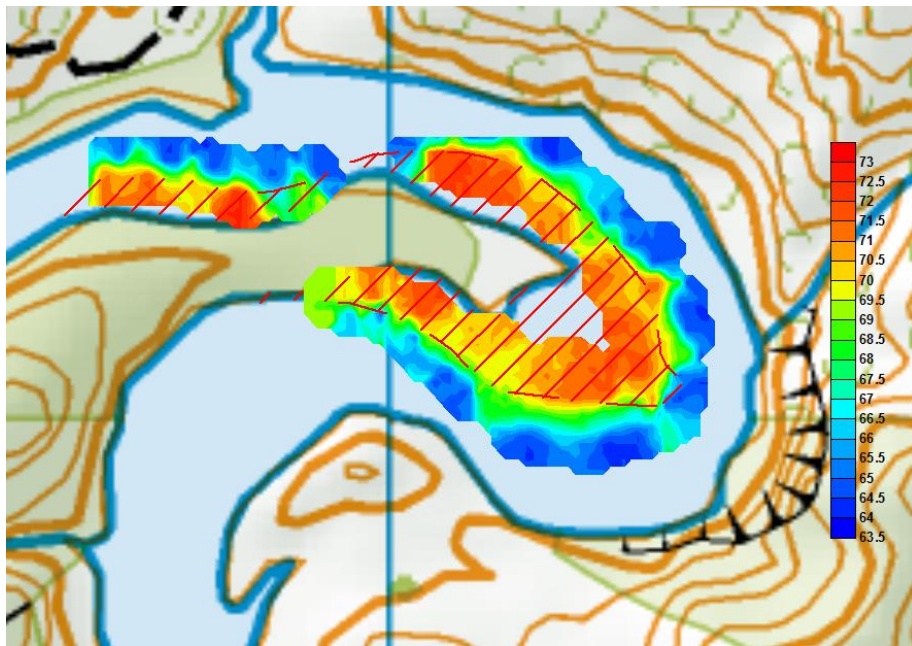
A5 – Large Semi Submerged Tree Area on right bank downstream of Otairira Stream.

A large shallow hazard area extends off this headland and is covered with weed, tree stumps and branches. With the low lake level it was evident that the scattered submerged tree branches extend out into the lake as shown above by the hatched hazard area.

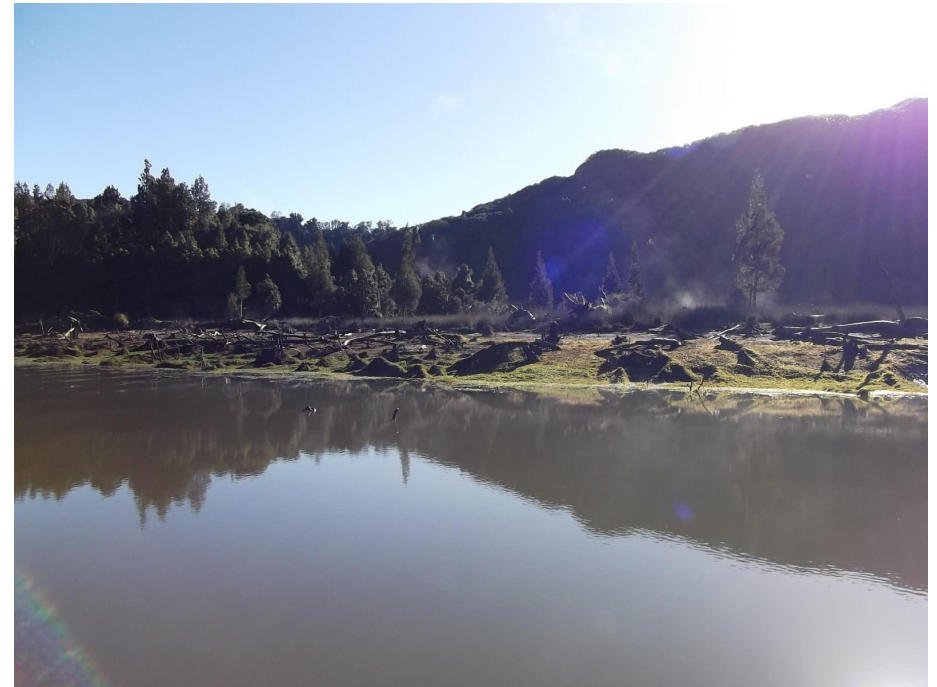
A5 – Large Semi Submerged Tree Area on right bank downstream of Otairira Stream.

Photo of the lake bank with tree stumps, branches and weed.

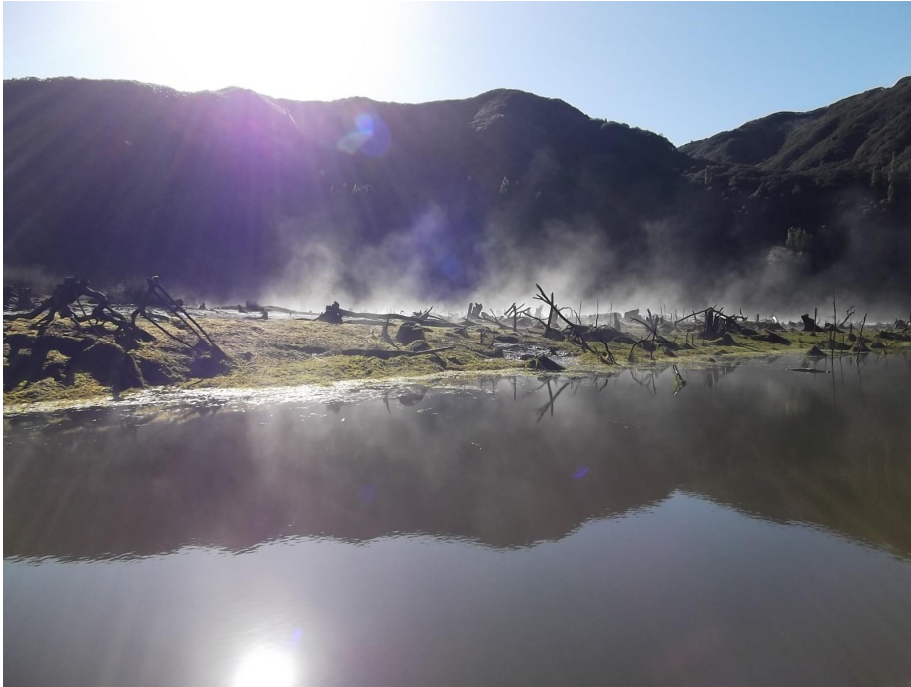
A5 – Large Semi Submerged Tree Area on right bank

Photo of the lake bank with tree stumps, branches and weed.

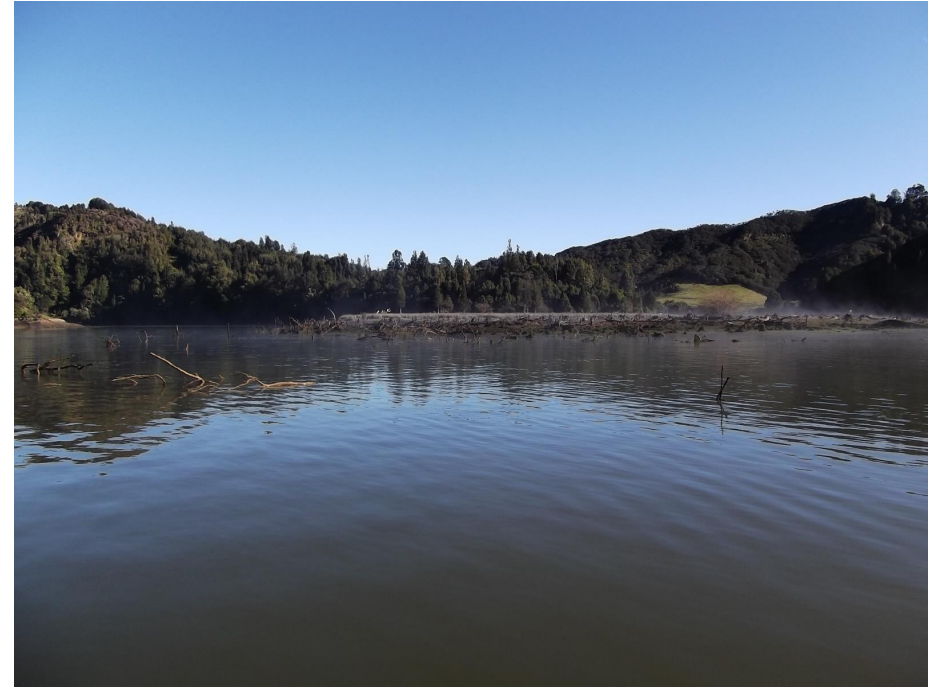
A5 – Large Semi Submerged Tree Area on right bank

Photo of the lake bank with semi submerged branches in the foreground.

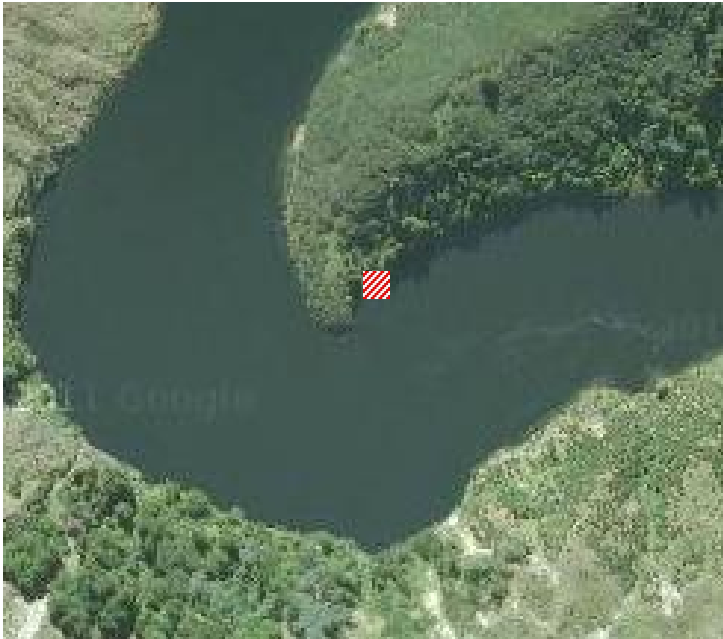
A6 –Submerged Tree Stump on left bank, upstream of HWSC

A 0.3m diameter tree stump was found submerged 0.05m and 5m from the lake edge. It is outside the safe navigation zone and close passage around this headland should be avoided.

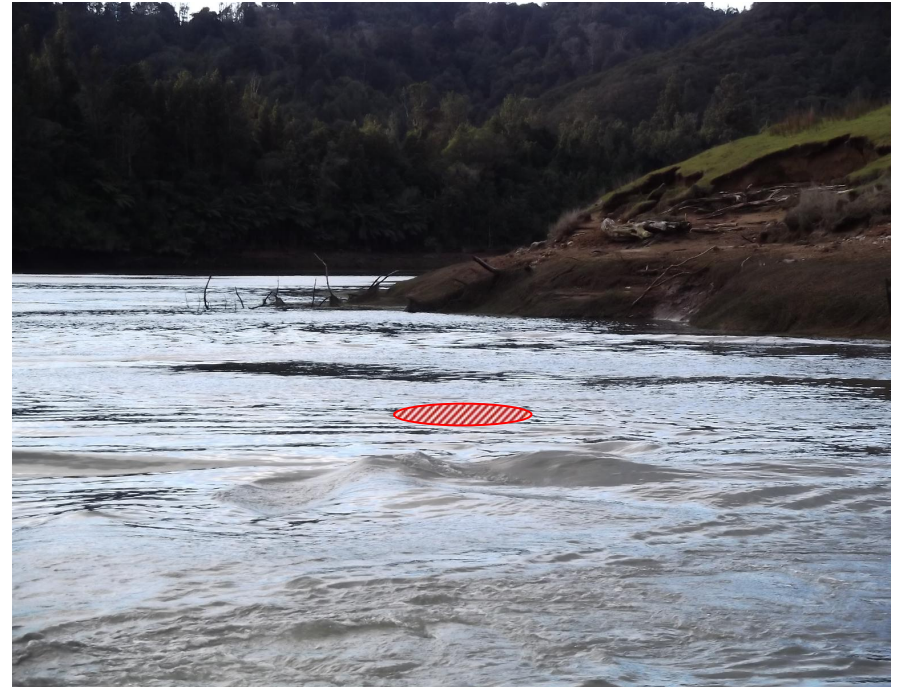
A6 –Submerged Tree Stump on left bank, upstream of HWSC

Photo showing approximate location of submerged tree stump.

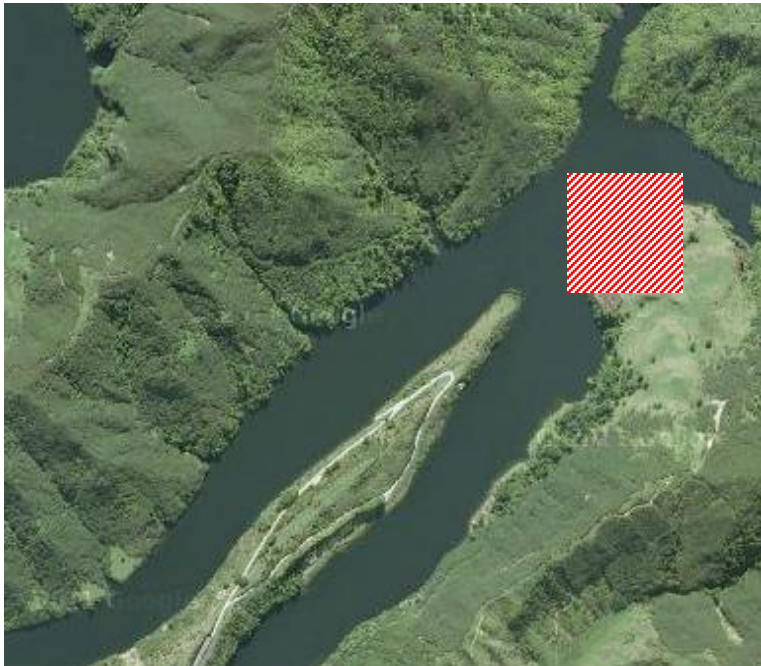
A7 – Weed covered shallow sandy area on left bank, upstream of HWSC

A sandy, weed covered bank extends into the confluence from the southern headland. There are large floating areas of weed in this area also

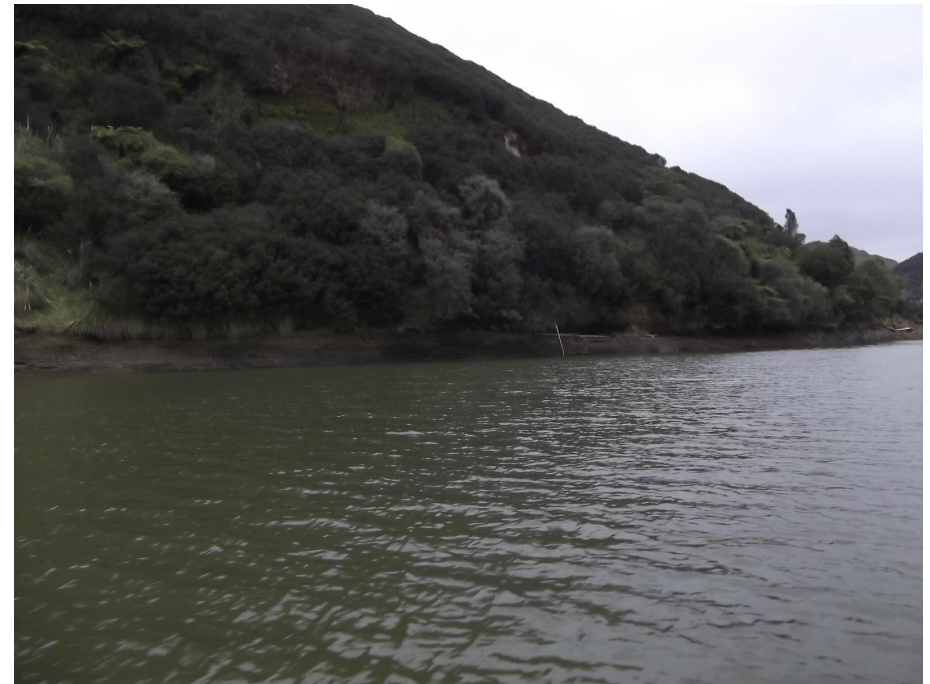
A8 – Submerged tree stumps close to bank on left bank opposite HWSC

Several tree stumps submerged 0.05m have been seen close to the bank in this area opposite HWSC.

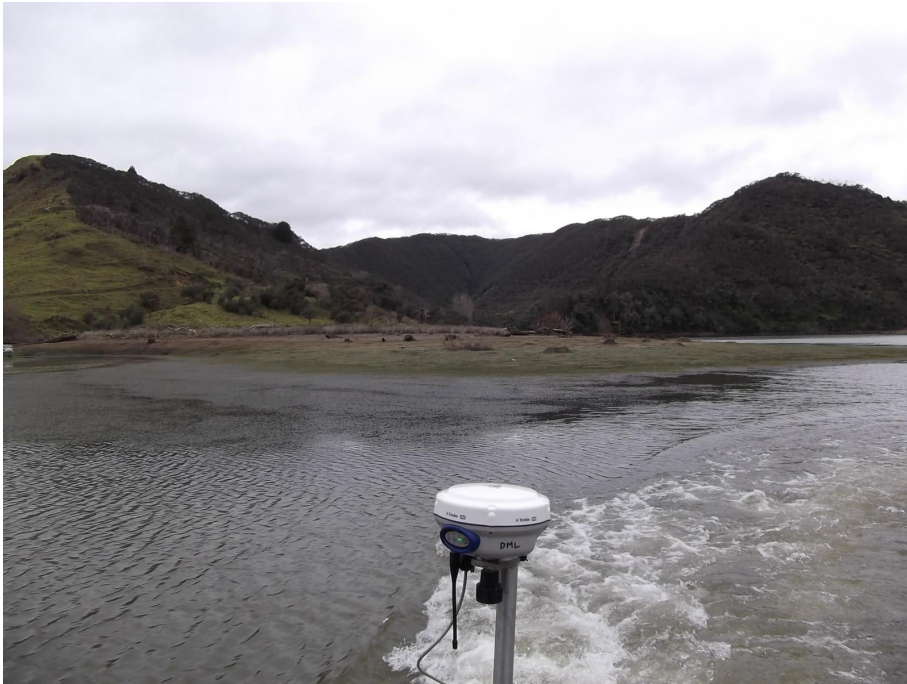
A9 – Weed covered, shallow, sandy area on left bank opposite Pukekino Road

A large sandy, weed covered bank extends out from the entrance to two small lake arms and a landing area. Bank was approximately 0.5m above the low lake level. There were also large areas of floating weed surrounding the bank

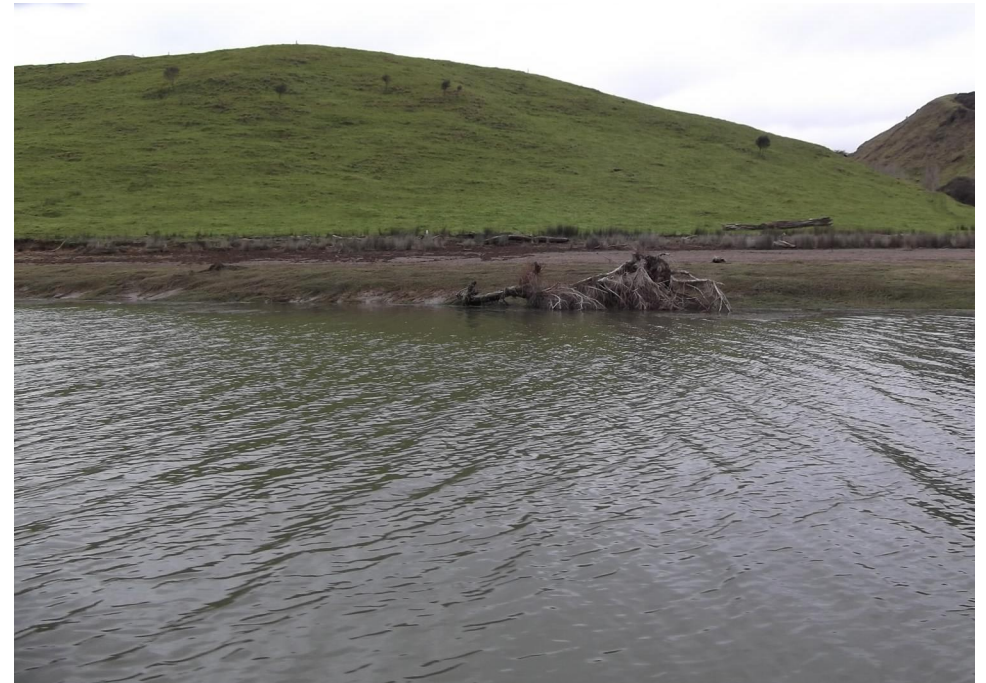
A9 – Weed covered, shallow, sandy area on left bank opposite Pukekino Road

Photo of a tree hazard close to the lake bank in the north of this area. Tree would be submerged with normal lake levels.

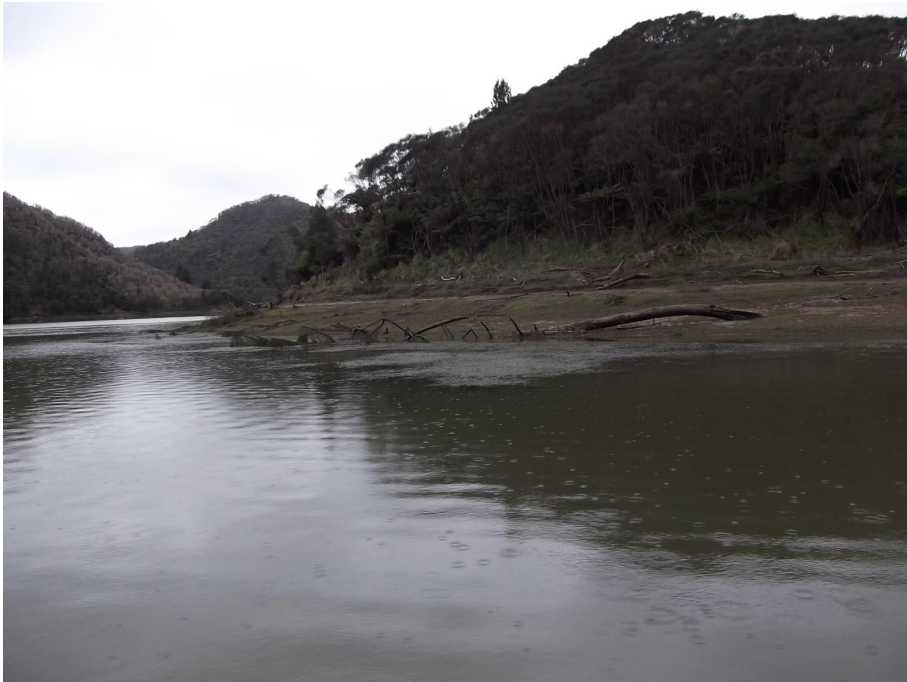
A10 – Felled trees on bank extending to water line & submerged on left bank, downstream of Pukekino Road

Fallen tree extending from lake bank into water. The end of this tree is submerged approximately 5m from lake edge. Tree would be covered with normal lake levels.

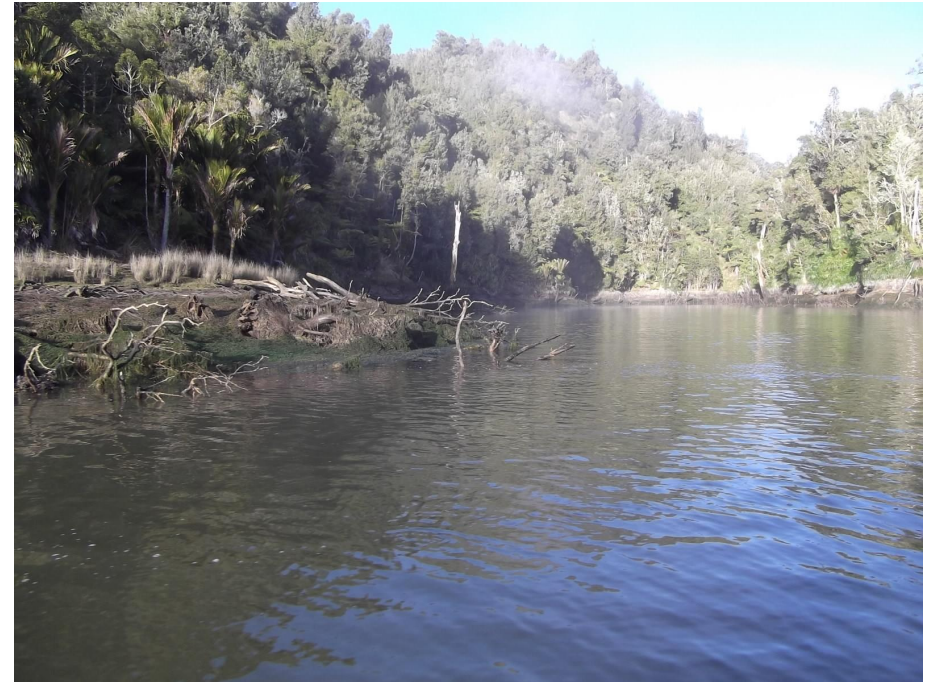
A11 – Submerged branches and weed near bank on right bank downstream of Pukekino Road

Tree branches extending out from shallow headland into water. Avoid passage close to the headland when entering small bay.

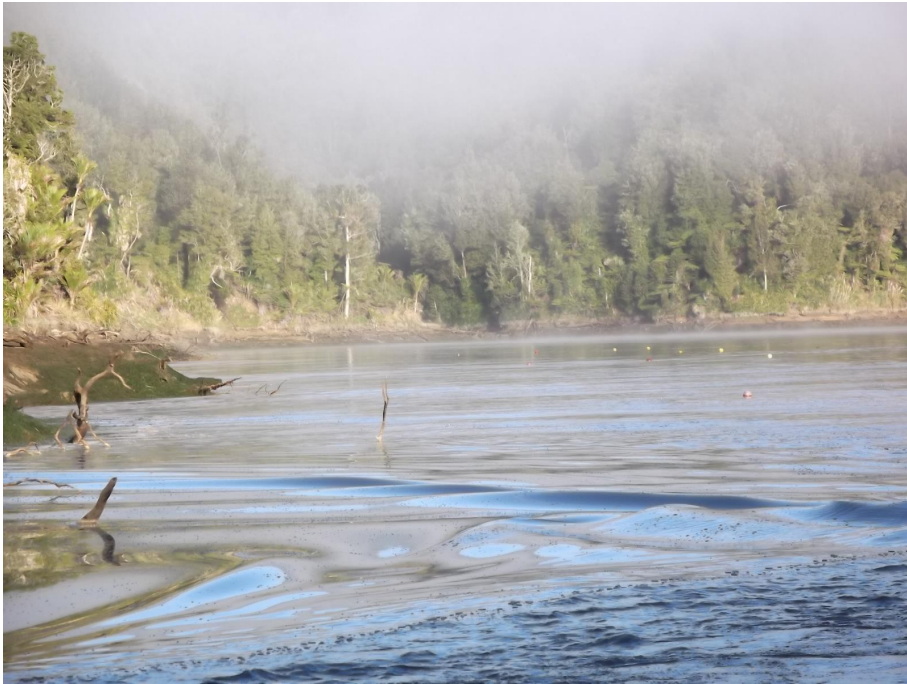
A12 – Submerged branches & weed near marker buoys on right bank

Several isolated tree branches and areas of floating weed have been seen, 5 to 10m off the lake bank close to some marker buoys. These buoys may be used as part of a ski lane. It is recommended that close passage to the lake bank be avoided in this area or the buoys moved further from the bank.

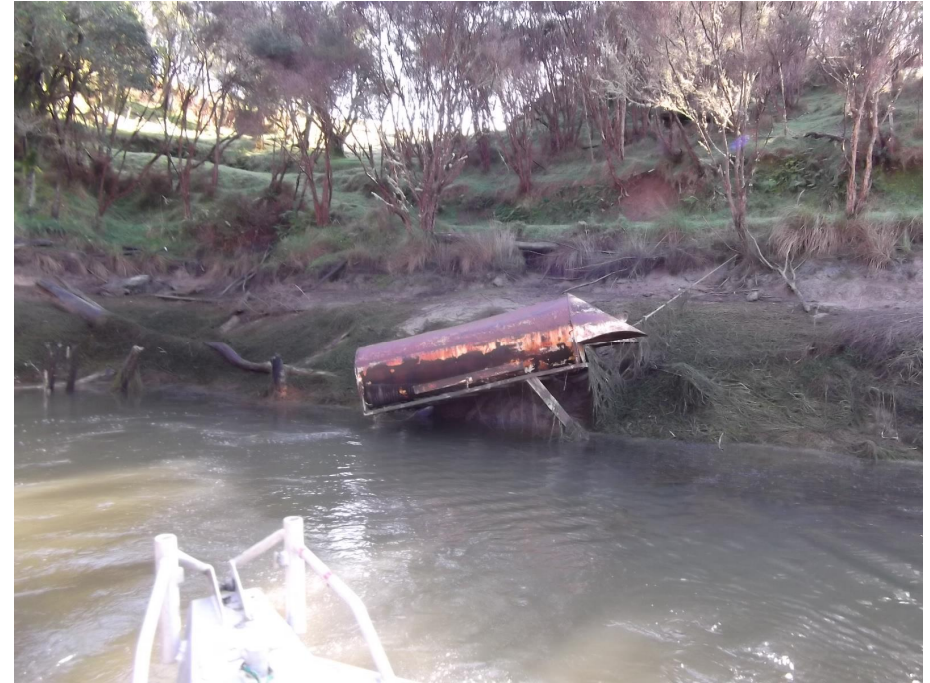
A13 – Small Raft/Wreck on right bank

What appears to be an upside down raft was found loosely tethered to the land. It is unsure whether this raft is floating or submerged when the lake is at its normal level.

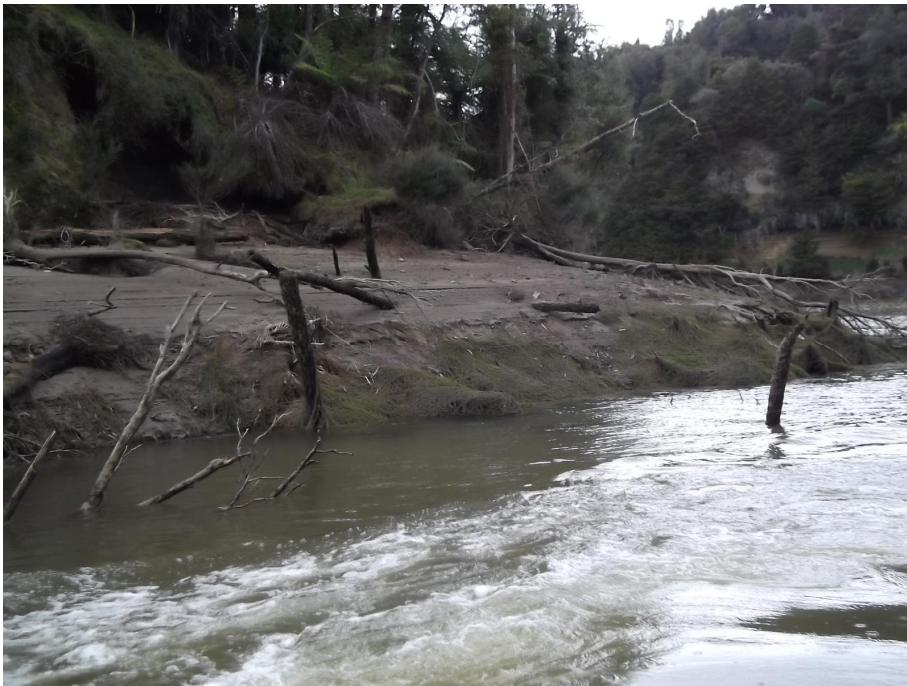
A14 – Fallen trees on bank and semi submerged branches on right bank

Photo showing tree stumps and branches extending into the lake on a narrow headland. Close passage to this headland should be avoided.

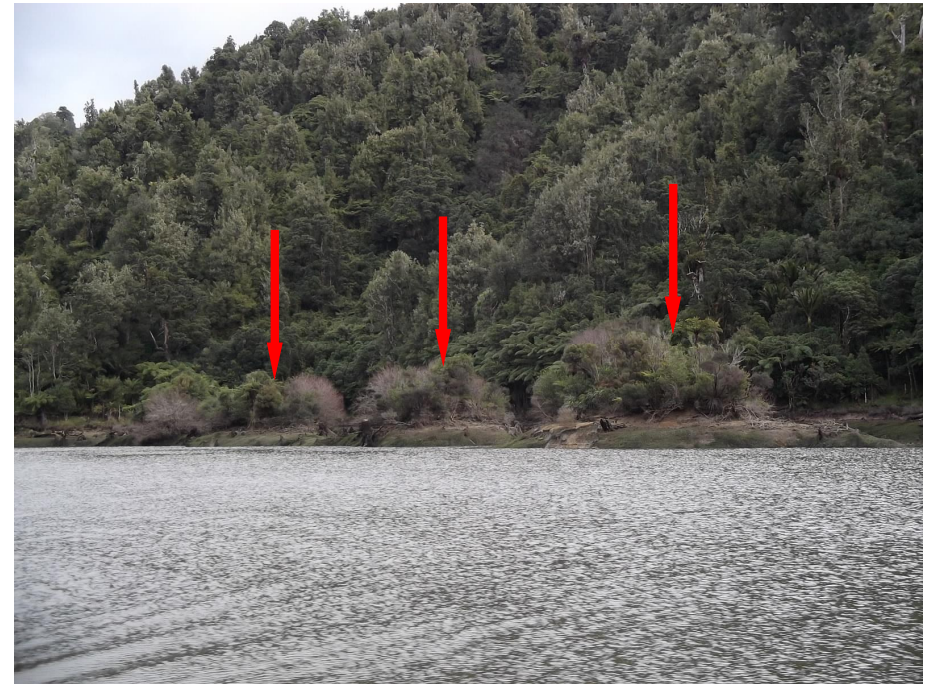
A15 – Normally submerged land area on right bank

Three clumps of bush that appear partially submerged at normal lake levels. It is recommended lake users avoid passage between these as its is shallow an there are numerous semi submerged branches surrounding them.

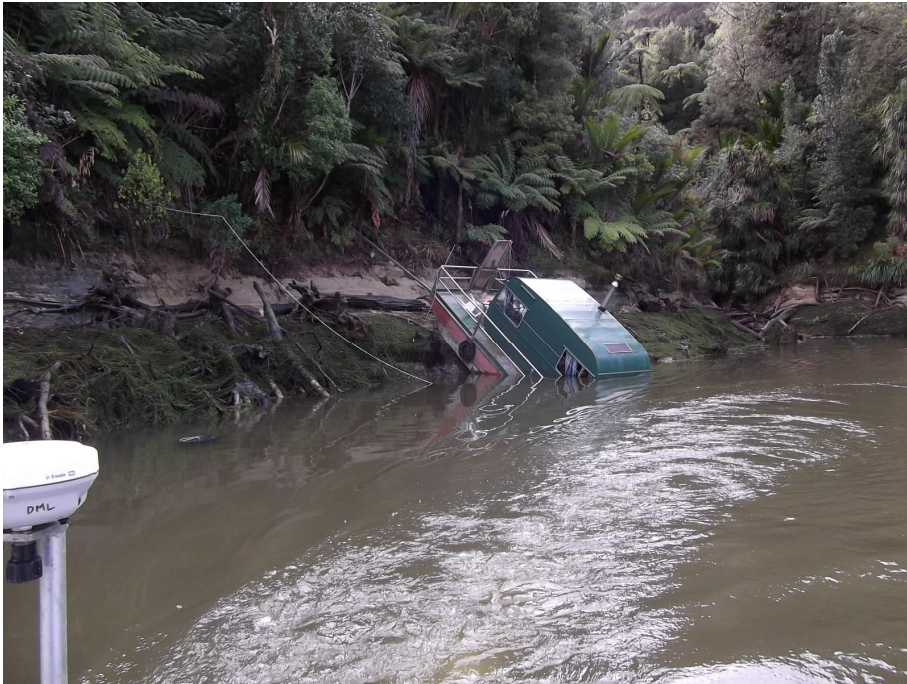
A16 – Partially Submerged Barge/Caravan on left bank, upstream of Patea Dam

A partially submerged caravan barge was discovered tethered to the lake bank. It is recommended lake users avoid this area as the barge may break free and become fully submerged.

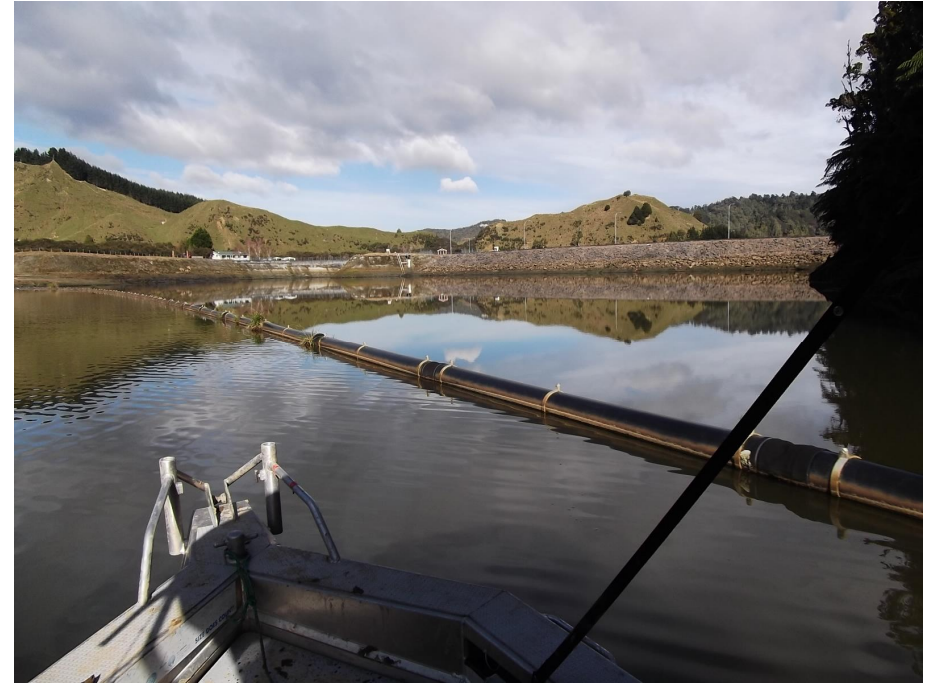
A17 – Patea Dam

A large boom extends across the lake in front of the dam wall.

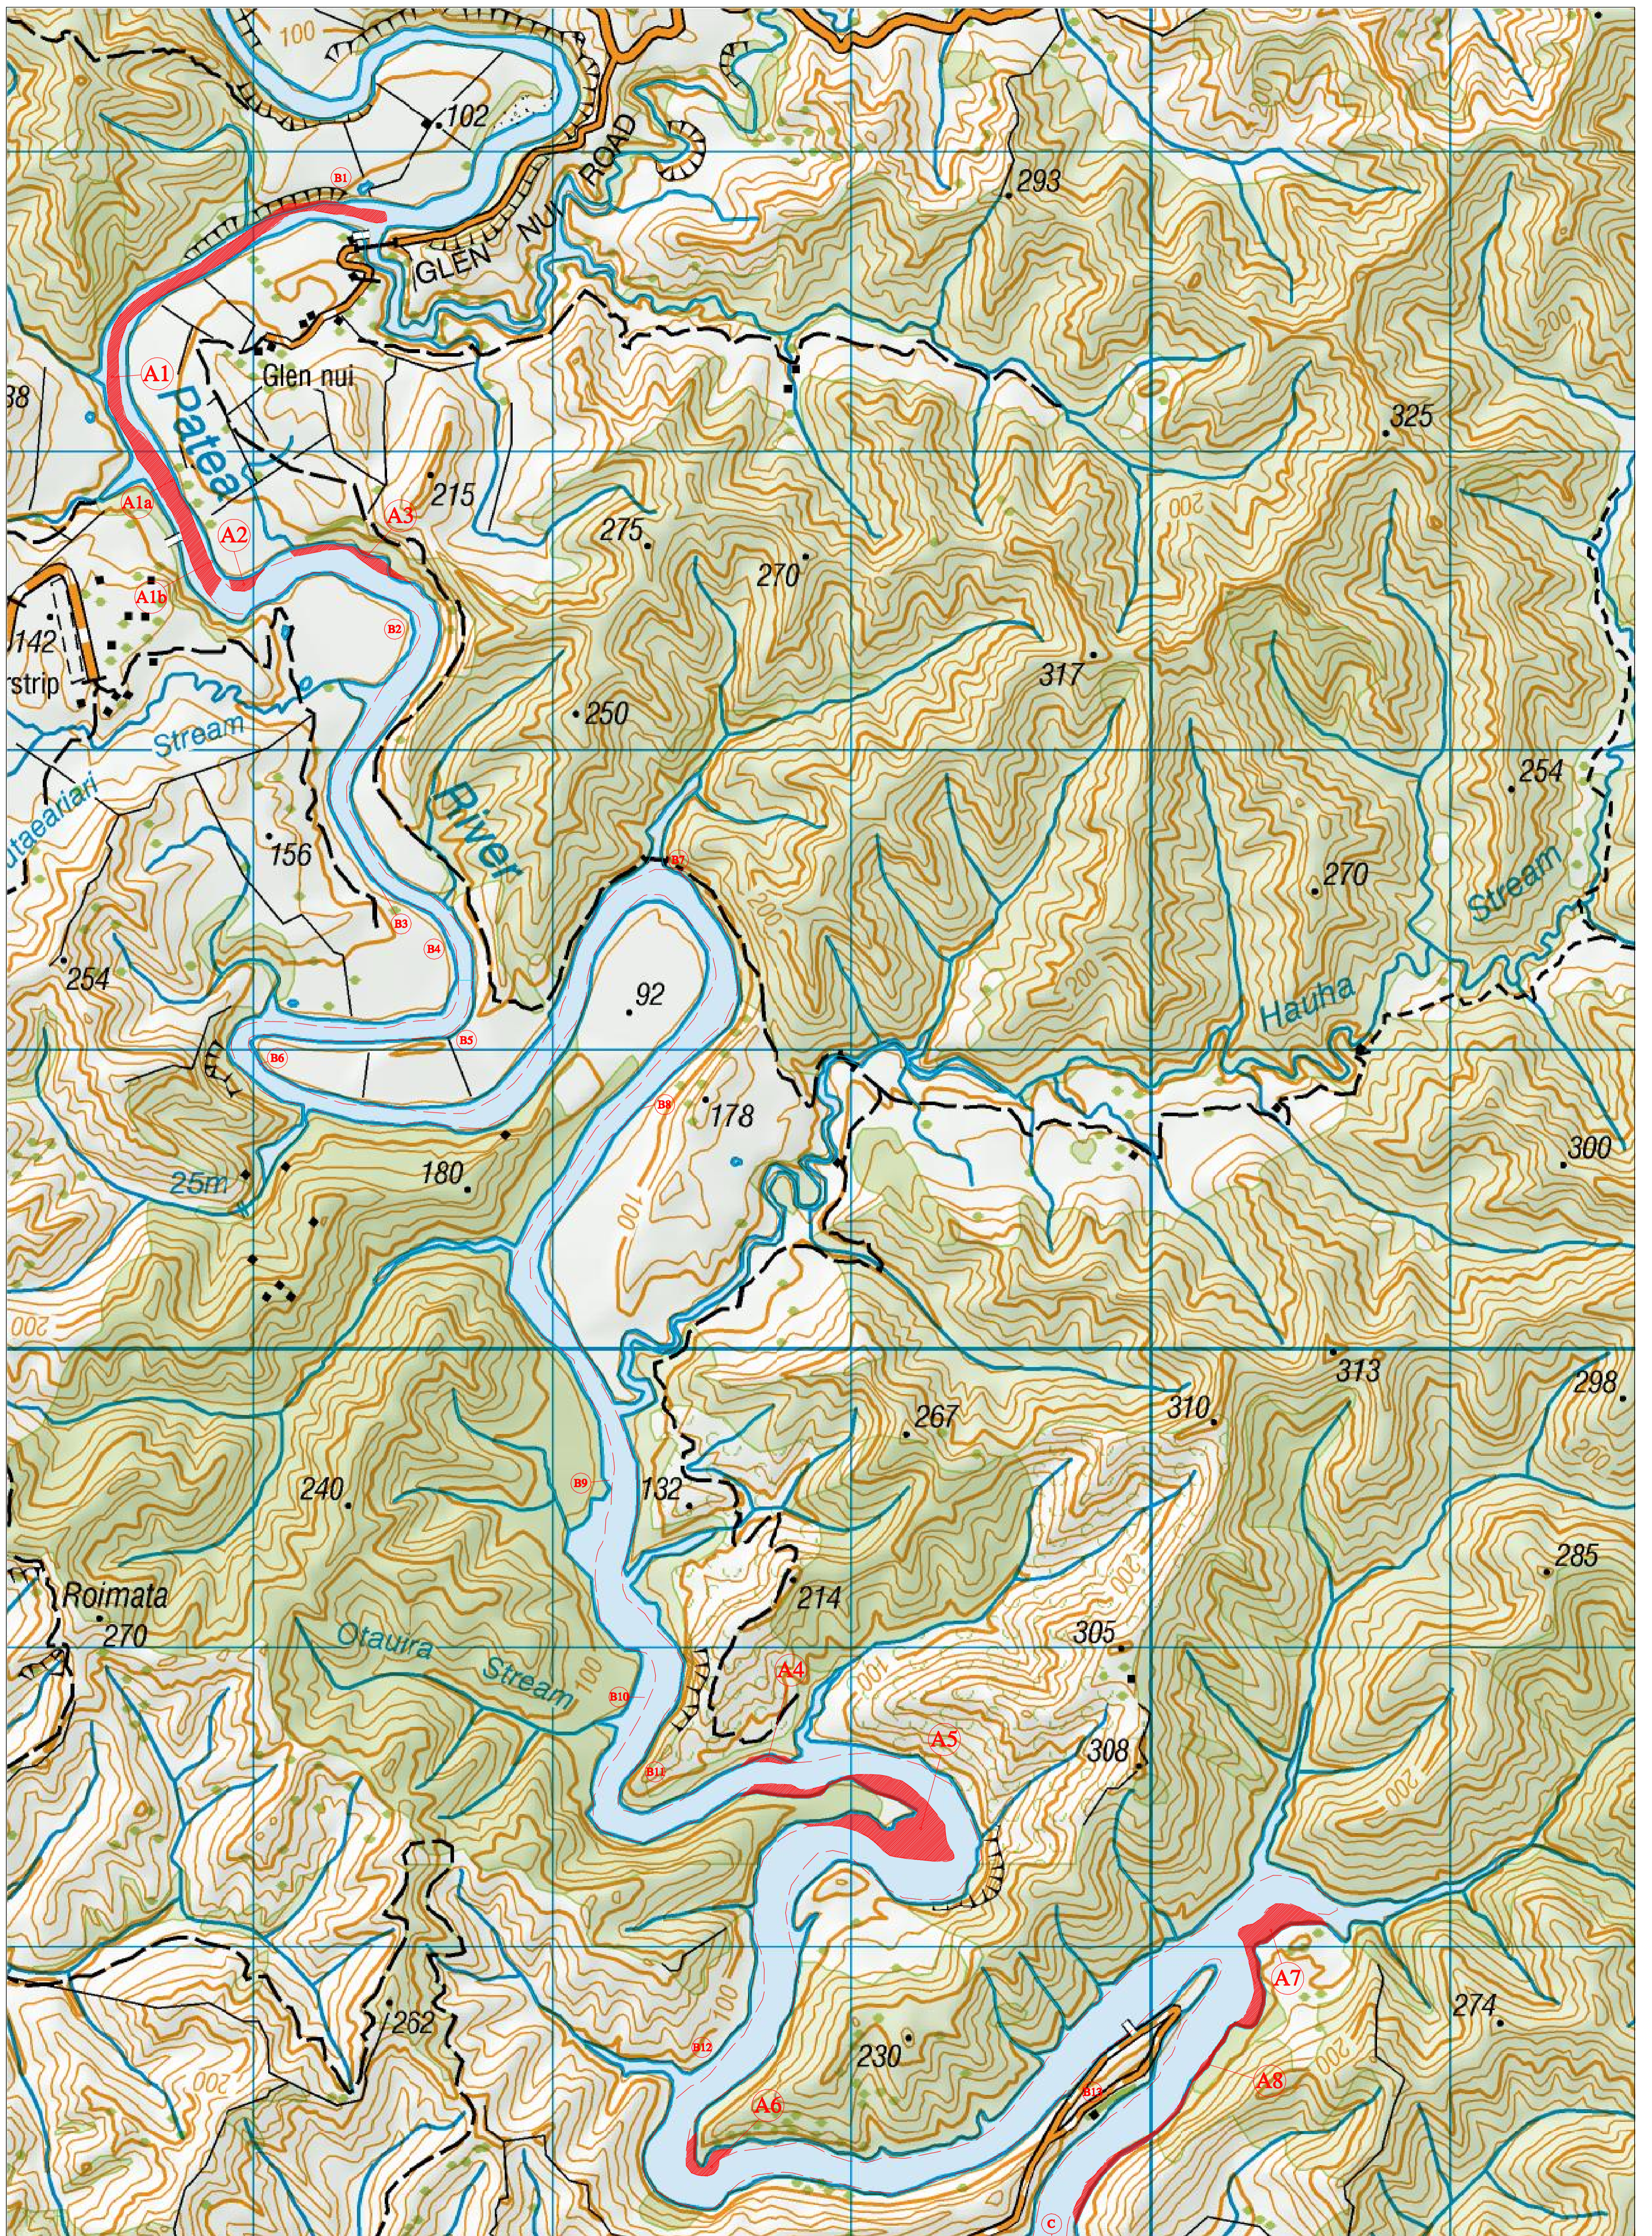
The low lake level allowed a visual survey of the lake bank to be undertaken and photographed (Lake bank photos in Appendix B). From analysis of the survey data and photographs, a safe navigation line has been determined around the lake edge and marked on the associated plans (11_13_1 & 11_13_2). The safe navigation line attempts to bound areas where weed or tree stumps and branches are hazardous to recreational lake users.

A number of significant hazards have been identified and numbered on the associated plans. These are outlined further in Appendix A. Shallow areas were noted to extend out from most headlands with the lake bed rising quickly. Caution should therefore be exercised while navigating around headlands close to the lake edge.

Due to the scale of the TOPO50 maps, it is difficult to accurately reference the safe navigation line to the physical lake edge, as the lake edge often deviates from the edge depicted on the NZTOPO50 maps. It is therefore recommended that where lake users are uncertain of the location of the safe navigation line, a minimum of 10m from the water edge be kept to avoid submerged hazards on the lake bed.
