Patea Hydro Electric Power Scheme

Lake Rotorangi Hazard Survey

Lake Rotorangi Hazard Identification Survey

Report Date: 26 August 2011
Surveyed Between: 25 – 27 July 2011

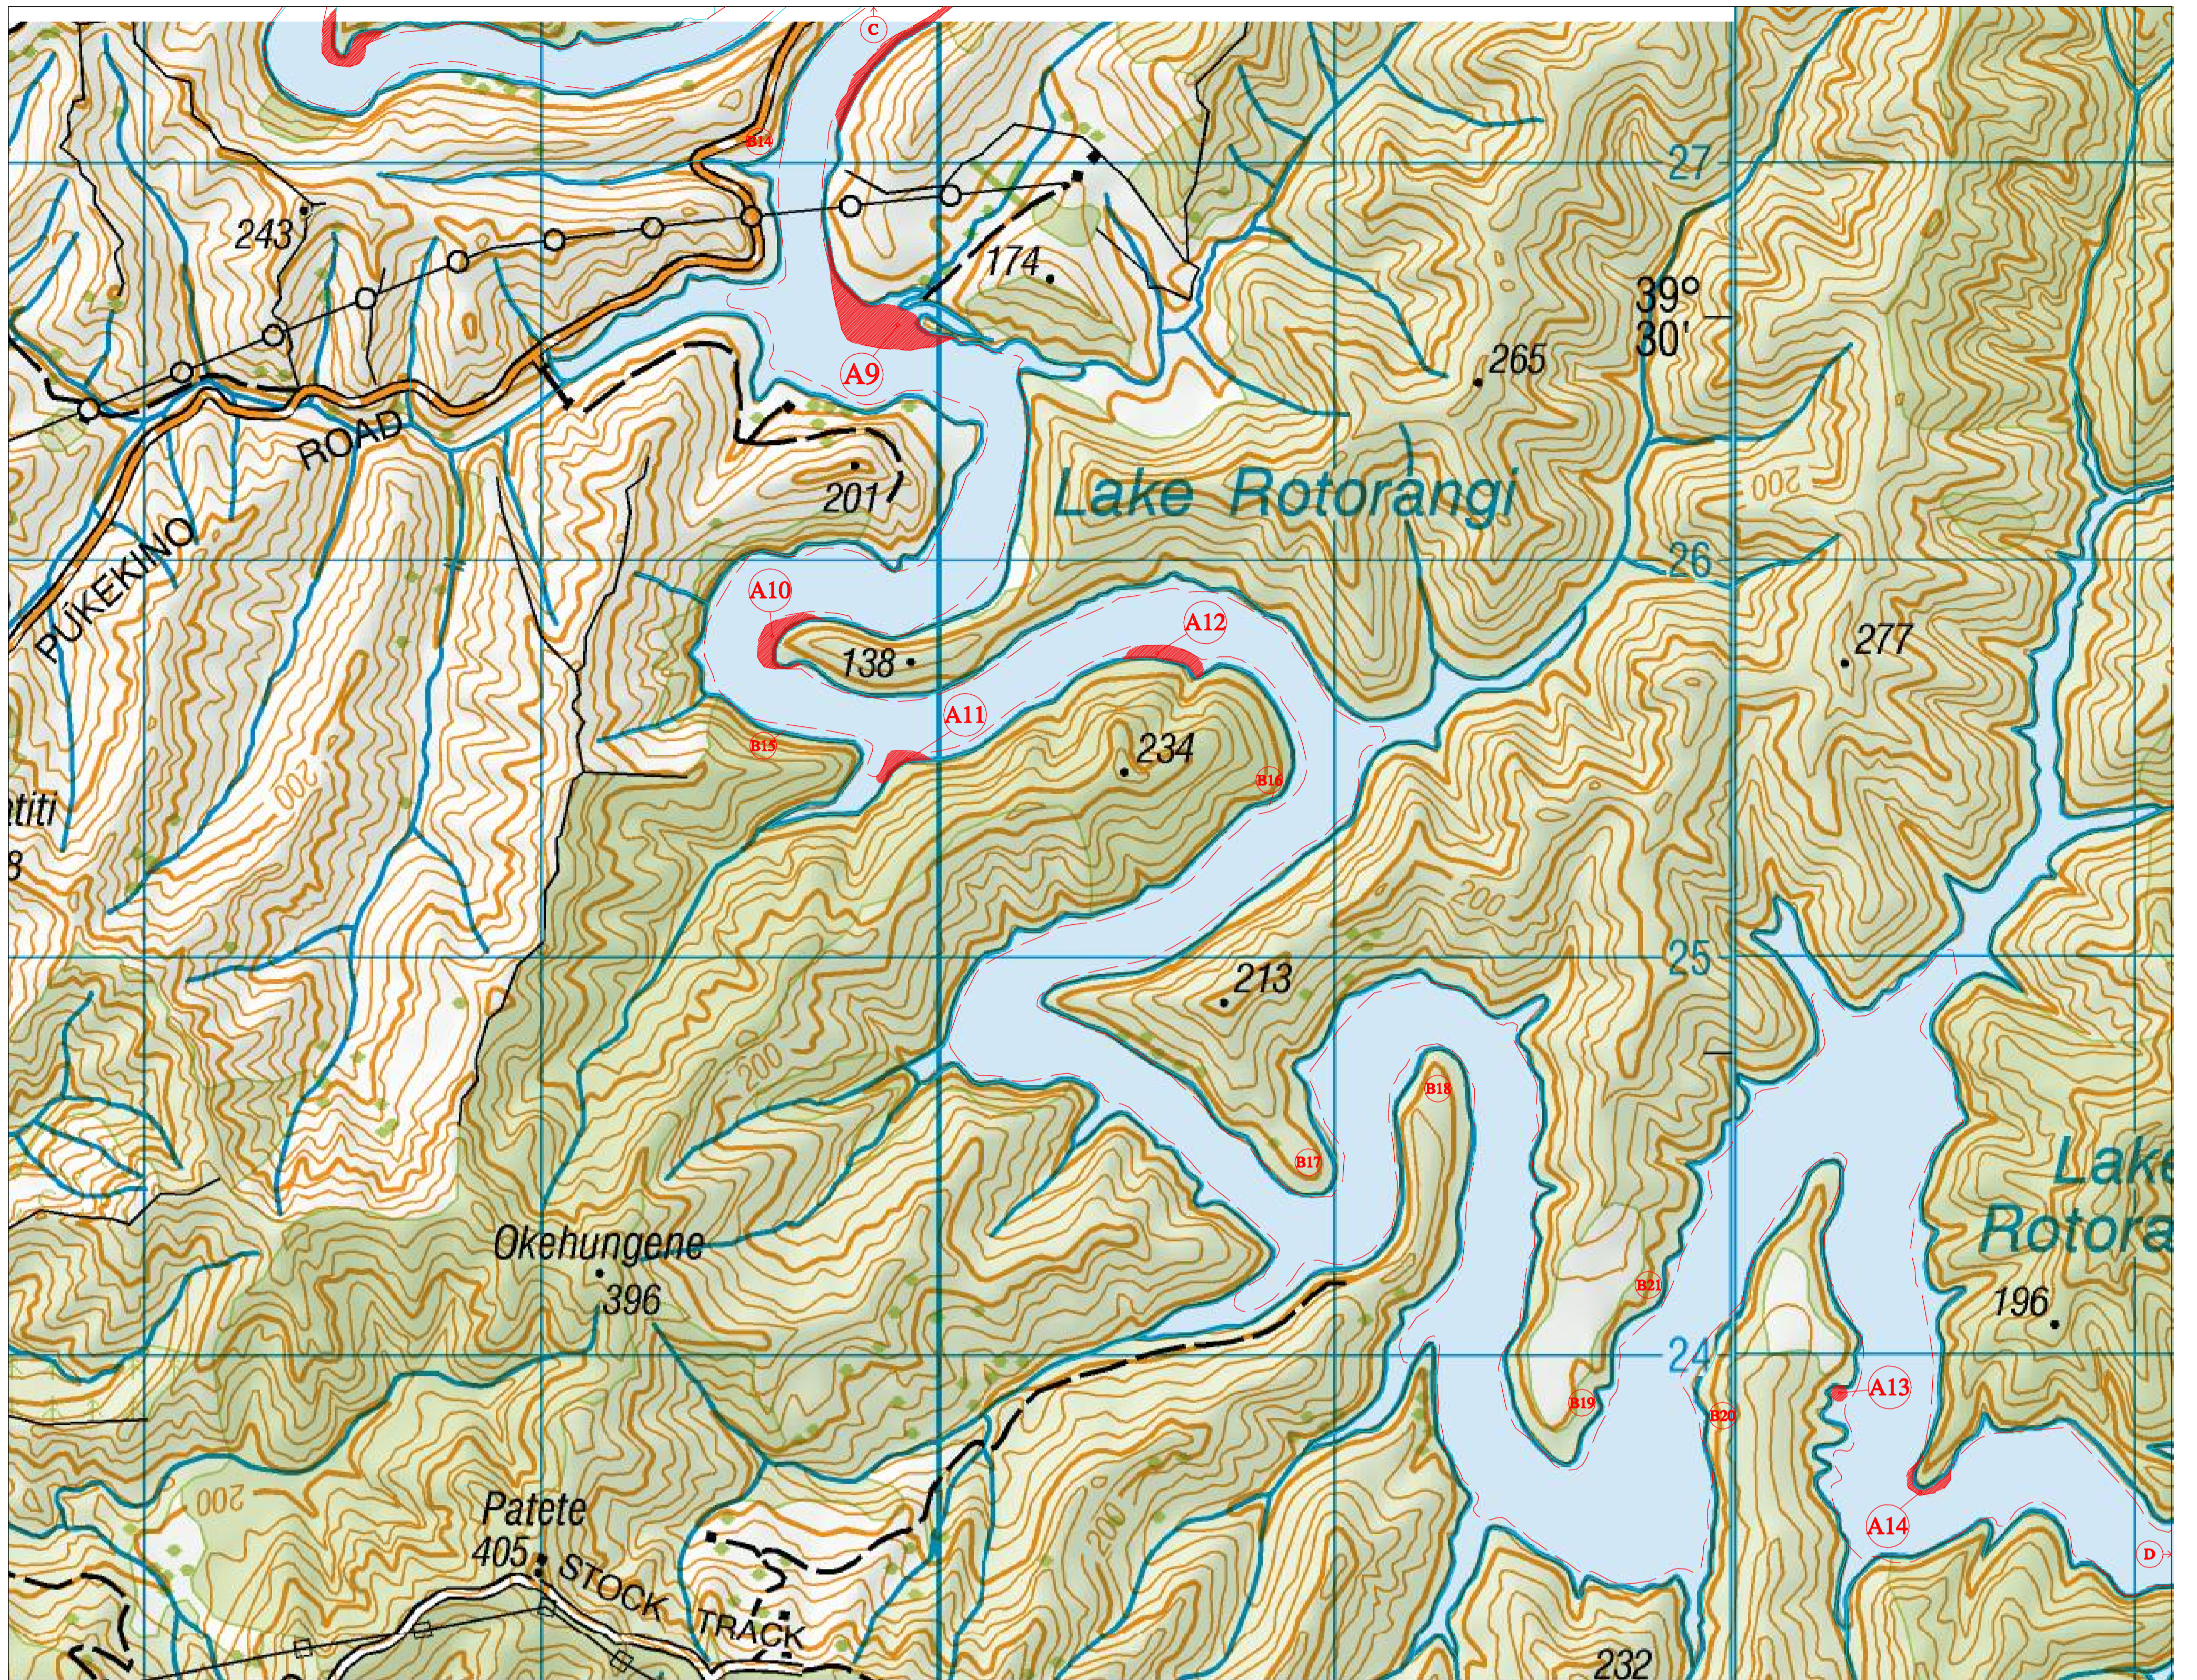
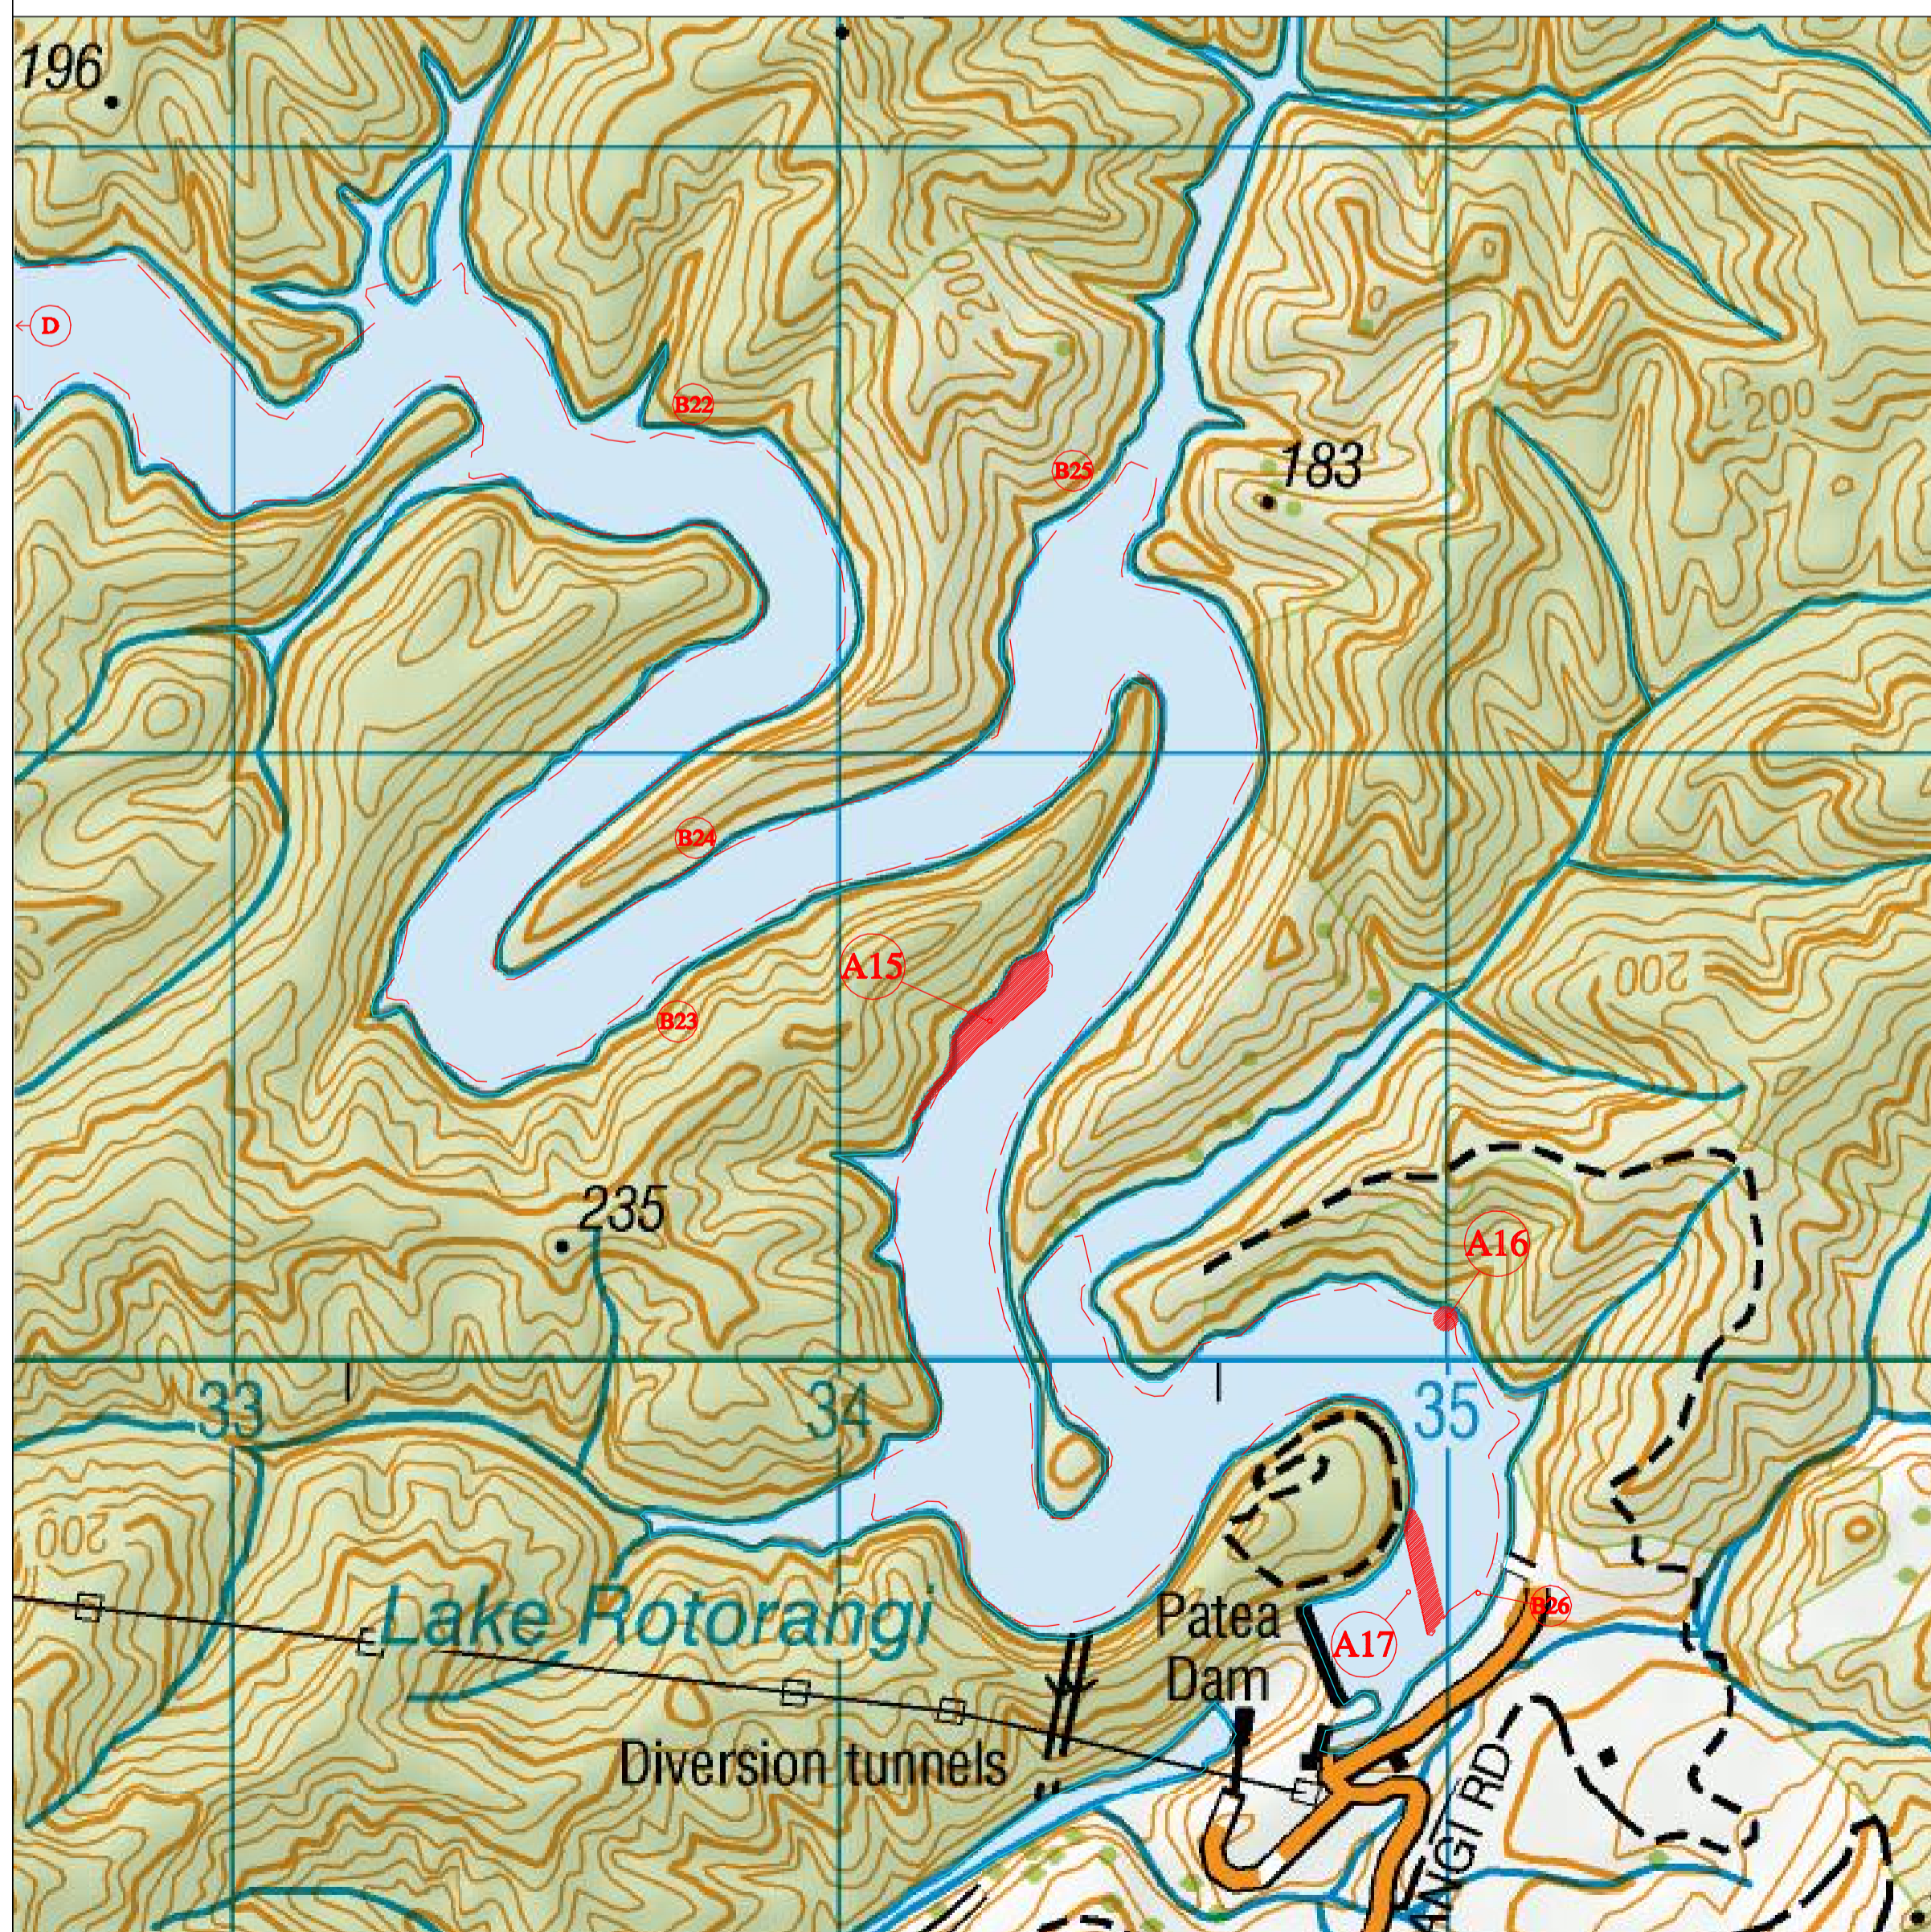
The low lake level allowed a visual survey of the lake bank to be undertaken and photographed (Lake bank photos in Appendix B). From analysis of the survey data and photographs, a safe navigation line has been determined around the lake edge and marked on the associated plans (11_13_1 & 11_13_2). The safe navigation line attempts to bound areas where weed or tree stumps and branches are hazardous to recreational lake users.

A number of significant hazards have been identified and numbered on the associated plans. These are outlined further in Appendix A. Shallow areas were noted to extend out from most headlands with the lake bed rising quickly. Caution should therefore be exercised while navigating around headlands close to the lake edge.

Due to the scale of the TOPO50 maps, it is difficult to accurately reference the safe navigation line to the physical lake edge, as the lake edge often deviates from the edge depicted on the NZTOPO50 maps. It is therefore recommended that where lake users are uncertain of the location of the safe navigation line, a minimum of 10m from the water edge be kept to avoid submerged hazards on the lake bed.
