Patea Hydro Electric Power Scheme

Lake Rotorangi Hazard Survey

Lake Rotorangi Hazard Identification Survey

Report Date: 26 August 2011
Surveyed Between: 25 – 27 July 2011

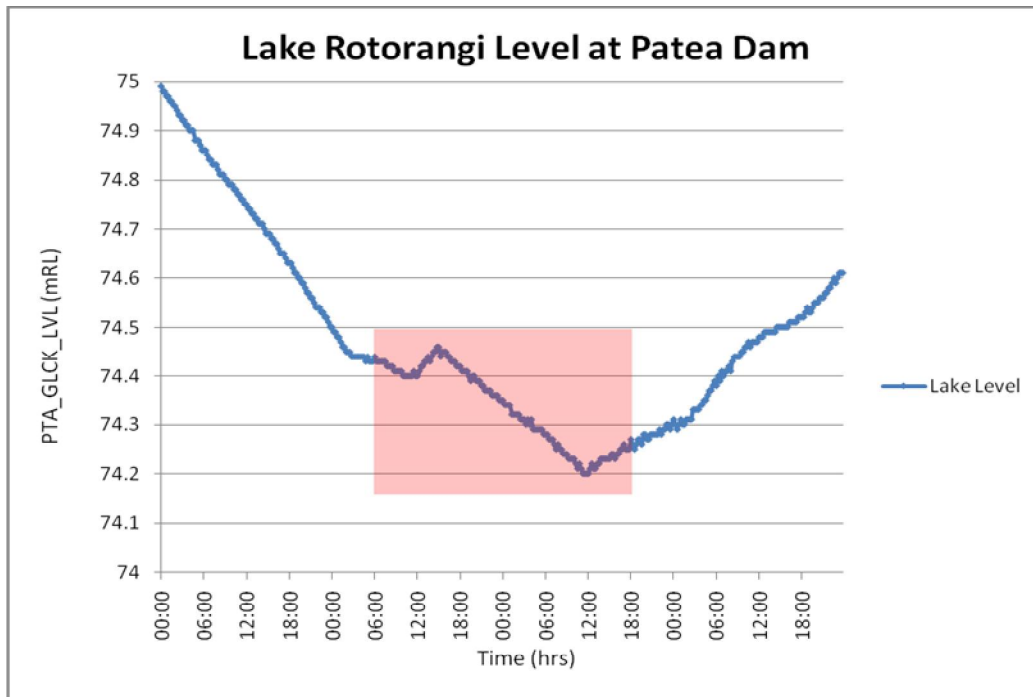
Due to the timing of DML mobilising to the area coinciding with construction work at the HWSC, the lake level was near its lowest consented level of 74mRL during survey operations. The low lake level exposed shallow banks, semi submerged tree stumps and braches and proved beneficial in identifying potentially hazardous areas for recreational lake users.

Figure 1: Graph of Lake Rotorangi Level from 12:00am 25th of July 2011 to 12:00am 29th July 2011. Red box indicates lake level during bathymetric survey operations.
